Subject: Driftwood Heights Association (ID #19948)  
Island County  
Routine Sanitary Survey

STATE OF WASHINGTON  
 DEPARTMENT OF HEALTH  
 NORTHWEST DRINKING WATER REGIONAL OPERATIONS  
 20425 72nd Avenue South, Suite 310, Kent Washington 98032-2388  
**SYSTEM INSPECTION / SANITARY SURVEY REPORT**  
 Date: December 9, 2013

**DRIFTWOOD HEIGHTS ASSOCIATION** Island County (ID #19948)

Purpose: Routine Sanitary Survey

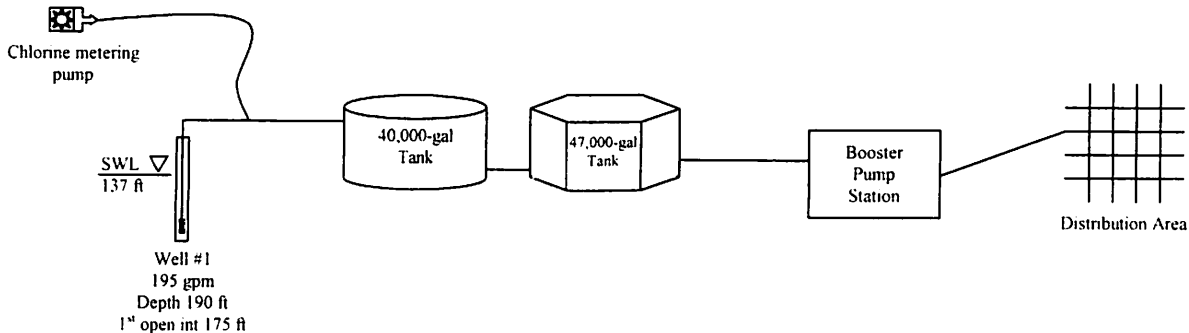
**SYSTEM SCHEMATIC**

System is currently modifying pressure system so a detailed pressure schematic is not included here.

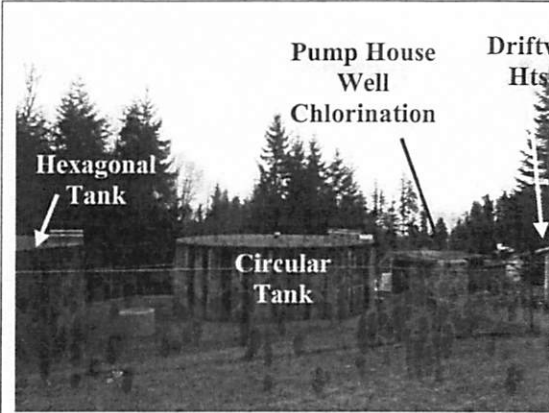
Well/tank site

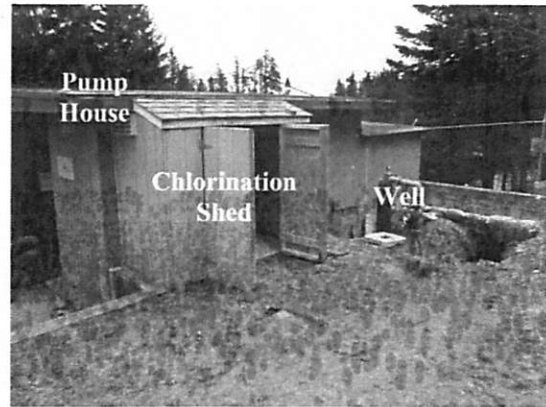
Well and pump house

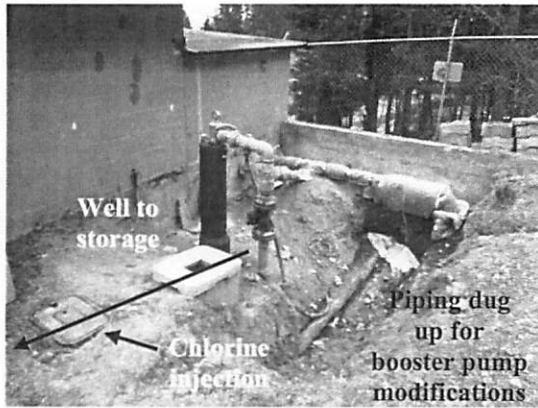
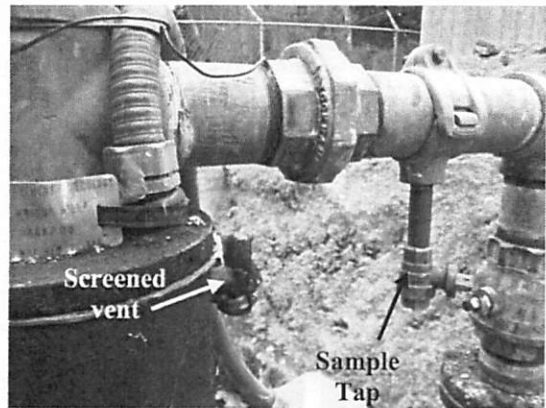
The area around the well head is currently dug up as part of the pressure system changes underway. The casing extends at least 24 inches above grade. The well pumps directly to the round tank and is controlled by level controls in the tank. There is a source meter, sample tap, and screened vent. The well site is fenced. There is a house on the lot adjacent to the well site on the south side that falls partially within the 100' radius. Hawthorne Lane runs along the east side of the well site with another lot that falls partially within the 100' radius.

Well #1

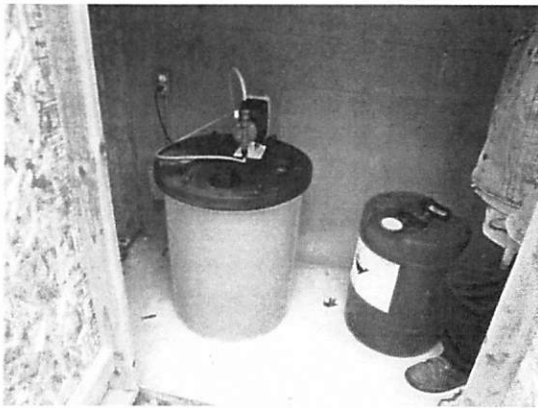
Facilities: 12.5% chlorine solution is used, diluted 1:10. The solution tank and metering pump are located in a shed next to the pump house and located near the well head. Chlorine is injected in a meter box between the well head and chlorine shed. A system operator visits the system at least twice/week and measures chlorine residual in the pump house and in the distribution system. A community member also measures chlorine residual on an occasional basis.

Chlorination equipment

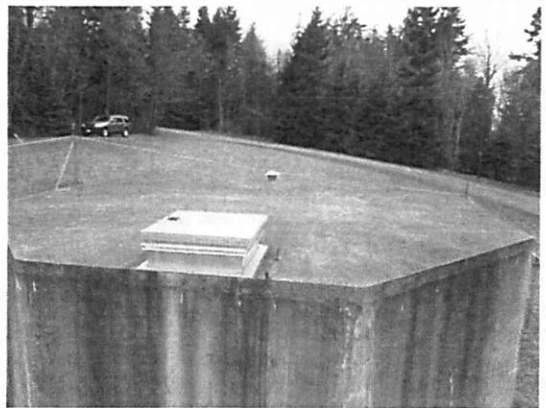
Looking at hexagonal tank

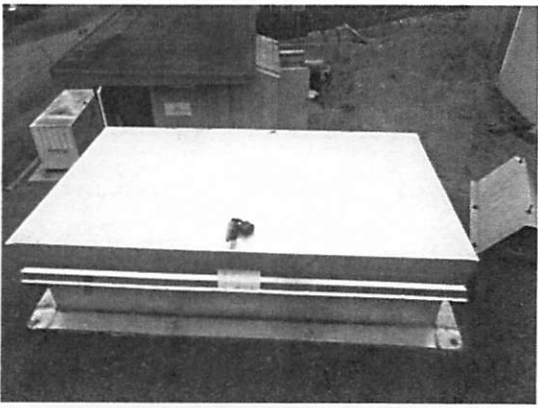
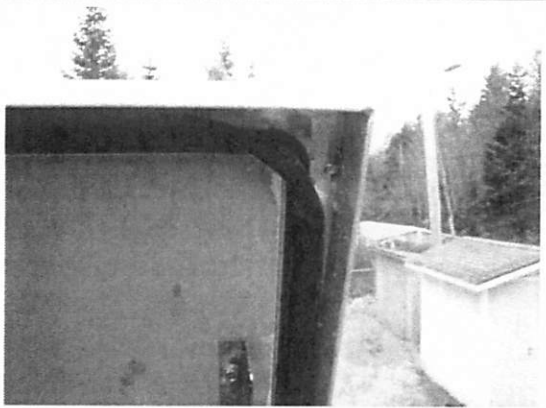
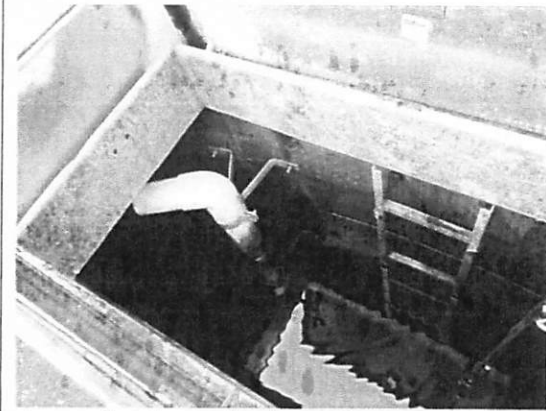
The circular tank is the first tank filled directly by the well. It has a dedicated inlet and separate outlet that then feeds the hexagonal tank. The hexagonal tank has a dedicated inlet and separate outlet that then feeds the booster pumps. There is a bypass that allows one or both tanks to be bypassed. The tanks were last cleaned about 2 years ago and are on a triennial cleaning schedule. There is also an annual inspection of the tanks. We only climbed and looked into the circular tank. The overflow and vent are adequately screened. The access hatch on the circular tank appeared to be in good condition and water clarity was good.

Access hatch on circular tank

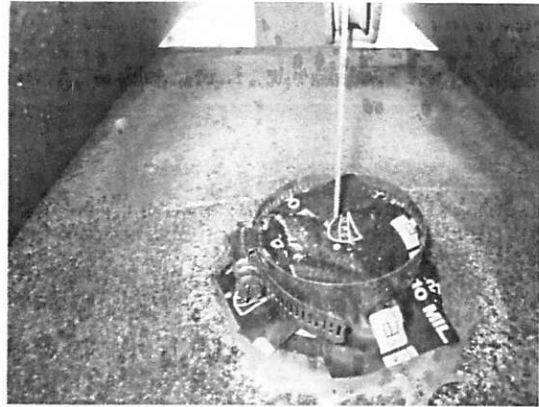
Level indicator wire on circular tank

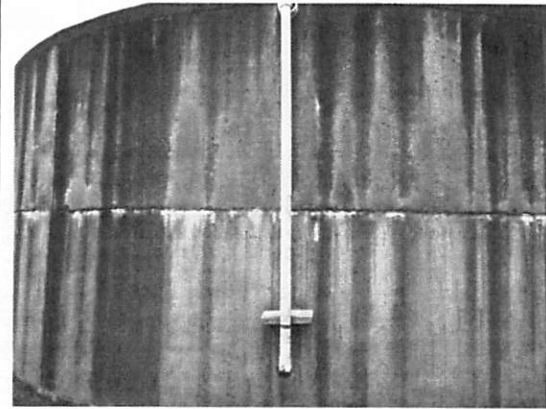
Screened overflow (typical of both tanks)

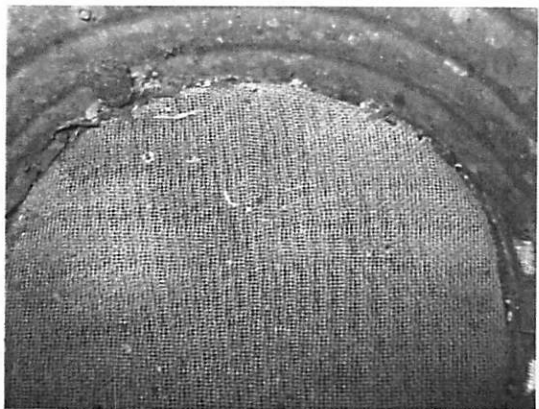
Screened vent on circular tank

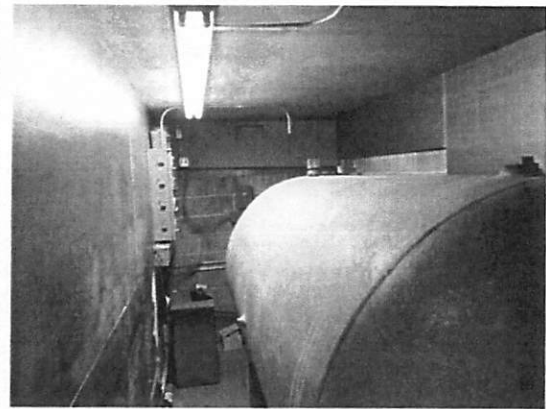
The system is currently only running on part of the total pressure system and has installed a PRV to reduce pressure to the lower zone. The system has been having problems with the smaller pressure tank so it is currently bypassed and is scheduled to be removed. There is a propane generator on-site; automatic testing occurs once/week.

Lower pressure system (larger pressure tank)

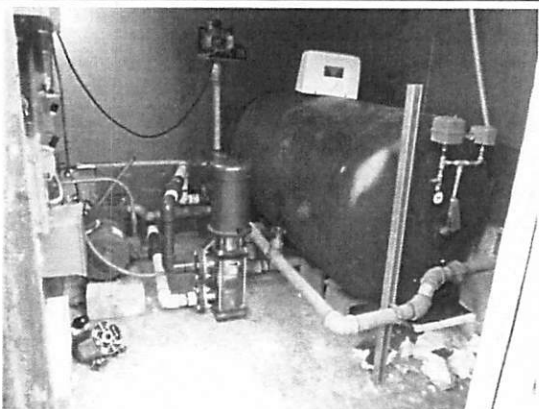
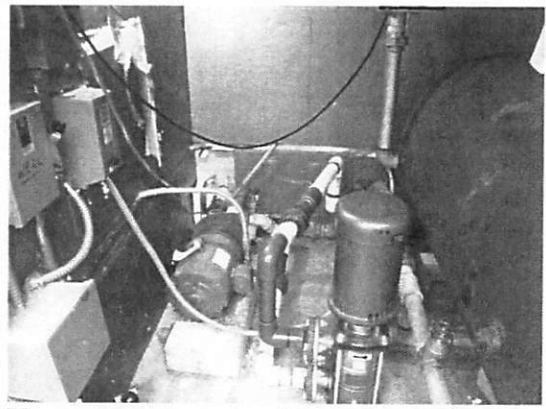
Upper pressure system (to be removed)

1. The modifications to the booster pump station are considered to be a change in the system design that requires DOH approval. You will need to work with your regional engineer, Erika Lindsey, to determine how she would like you to address this issue. Please contact Erika to discuss the next steps.
2. Even though your system is all residential, you should still have a cross connection control program. The first step can be to send out a questionnaire to all of the customers to determine the extent of the other program components that would be needed.
